Old Saybrook Coastal Resilience Committee

OSCRC Report No. 2

Meeting Summary

April 21, 2022

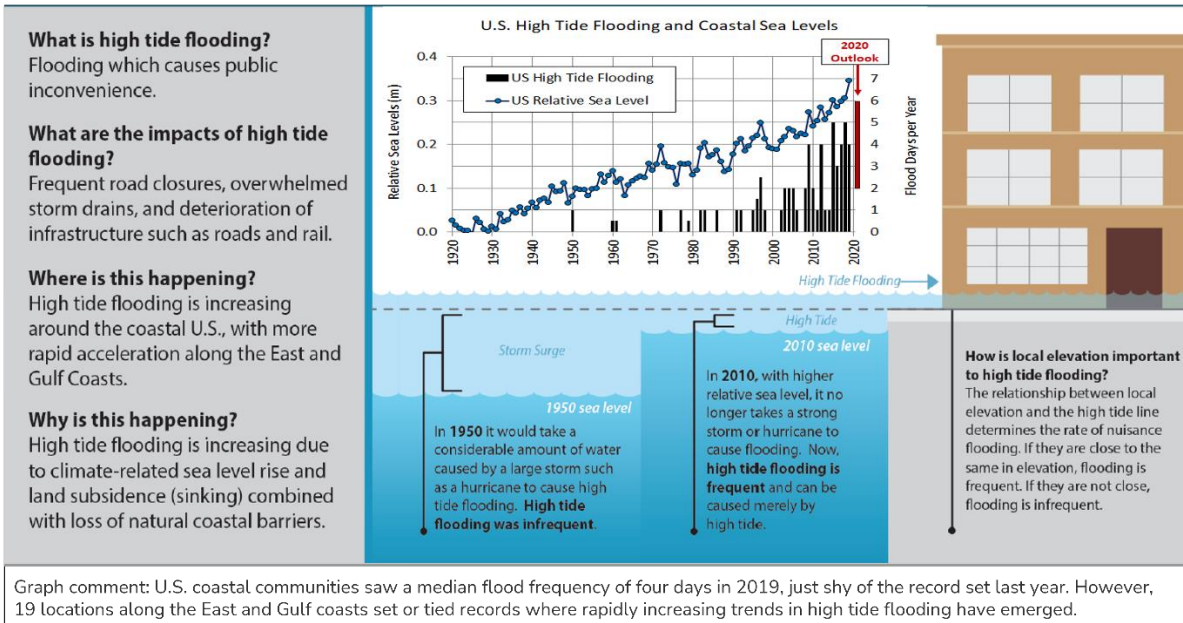
Slide 4: Tidal Flooding on Roads and Property

Slide 4 Note: Explanation of tidal flooding, including impacts, where its happening and why. Graph in upper center of slide shows the steady increase flood days nationally over the last century.

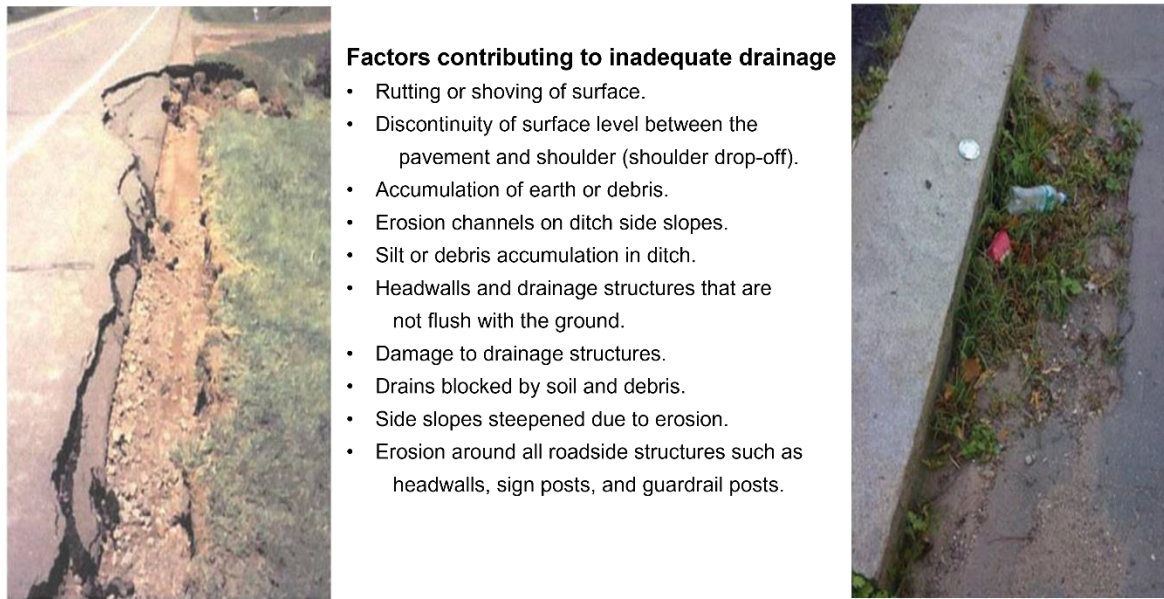
Slide 8: Inadequate Drainage of Roads and Properties

Factors contributing to inadequate drainage

- Rutting or shoving of surface.
- Discontinuity of surface level between the pavement and shoulder (shoulder drop-off).
- Accumulation of earth or debris.
- Erosion channels on ditch side slopes.
- Silt or debris accumulation in ditch.
- Headwalls and drainage structures that are not flush with the ground.
- Damage to drainage structures.
- Drains blocked by soil and debris.
- Side slopes steepened due to erosion.
- Erosion around all roadside structures such as headwalls, sign posts, and guardrail posts.

Slide 8 Note: Factors contributing to the inadequate drainage of roads and properties.

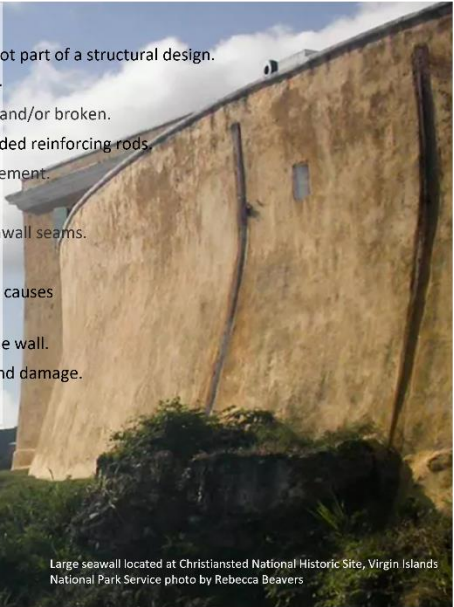
Slide 10: Deterioration of Seawalls

- Leaning seawalls – Leaning seawalls is a sign your anchor system has deteriorated and/or broken.
- Waterline failure – Due to uneven pressure, aged concrete, and corroded reinforcing rods.
- Sunken spots – Sunken spots in yard near seawall indicate soil displacement.
- Small holes - Small holes next to the seawall due to loss of soil.
- Soil discoloration - Different soil or sand is forming at base of your seawall seams.
- Cracks – Cracks or chipping along the top of your seawall cap.
- Toe and berm failure – Due to lack of enough berm at seawall bottom causes panels to tilt out, crack, rotate or fracture the cap.
- Change in water depth - Causes imbalanced water pressure against the wall.
- Inadequate drainage – Trapped water behind seawall causes cracks and damage.
- Severe weather – Storm surge and high winds stress the seawall.

Large seawall located at Christiansted National Historic Site, Virgin Islands
National Park Service photo by Rebecca Beavers

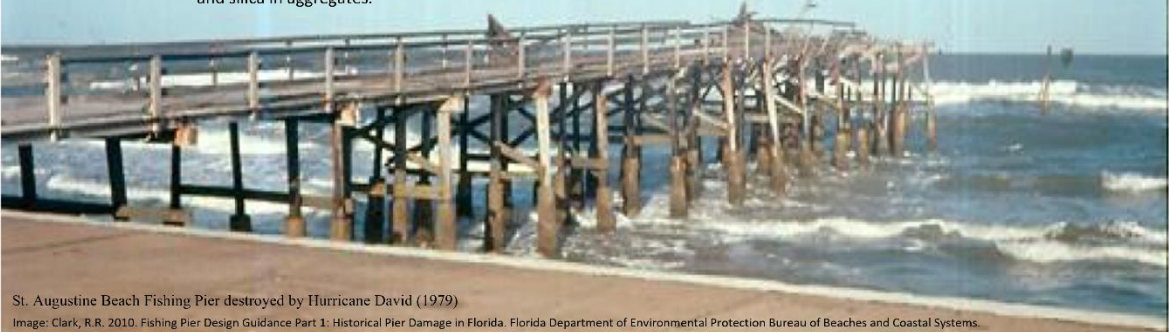
Slide 11: Deterioration Concrete Marine Structures

St. Augustine Beach Fishing Pier destroyed by Hurricane David (1979)
Image: Clark, R.R. 2010. Fishing Pier Design Guidance Part 1: Historical Pier Damage in Florida. Florida Department of Environmental Protection Bureau of Beaches and Coastal Systems.

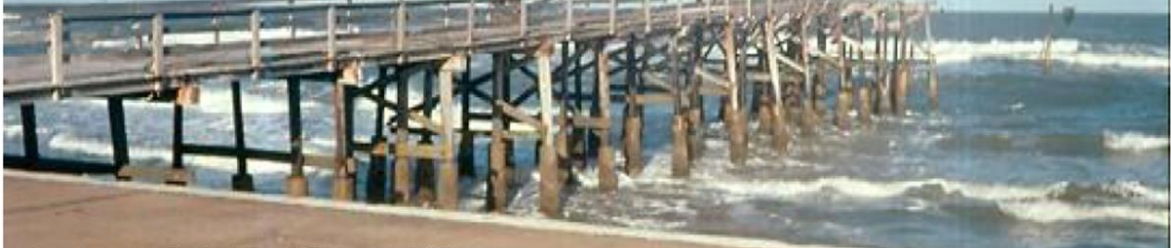
St. Augustine Beach Fishing Pier destroyed by Hurricane David (1979)
Image: Clark, R.R. 2010. Fishing Pier Design Guidance Part 1: Historical Pier Damage in Florida. Florida Department of Environmental Protection Bureau of Beaches and Coastal Systems.

Physical: Overstressing – High-impact loading reduces the stiffness of wood and results in sagging.
Shrinkage – As wood dries, shrinkage causes checks and splits which result in mechanical failure of surfaces.
Shredding – Intermittent wetting by sea water causes wood fibers to separate resulting in a loss of structural integrity.

Chemical: Acids or Alkalis – Strong acids or alkalis contacting wood, usually from spills, results in decomposition of wood constituents.
Metal sickness – Wood adjacent to metal fasteners (such as iron nails, screws, and bolts) breaks into small cubicle pieces resulting in the loosening of joints or fittings.

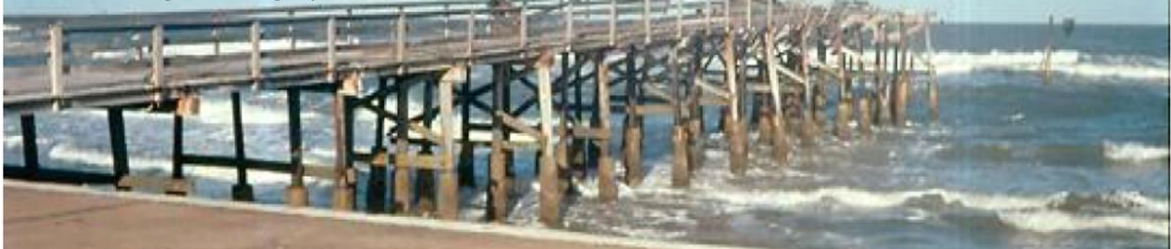
St. Augustine Beach Fishing Pier destroyed by Hurricane David (1979)
Image: Clark, R.R. 2010. Fishing Pier Design Guidance Part 1: Historical Pier Damage in Florida. Florida Department of Environmental Protection Bureau of Beaches and Coastal Systems.

Reinforcing Steel: Carbonation – Atmospheric carbon dioxide enters concrete forming weak carbonic acids which lower pH and results in a loss of passivity of the oxide layer preventing corrosion .
Chloride ion contamination – Chloride contaminated water breaks down the oxide layer protecting steel from corrosion.
Electrochemical corrosion - Electrochemical corrosion occurs when two dissimilar metals are present in an electrolytic medium, such as sea water, resulting in a corrosive chemical reaction on the surface of steel.

Exposed Steel: Dirt and salt – Surface dirt and salt in humid conditions and not subject to washing by rain can cause corrosion of steel.
Pollution – Atmospheric sulfur dioxide and nitrogen oxides are corrosive agents to metals.
Marine atmosphere – Marine atmosphere has aerosol comprised of fine particles suspended in the air (jet drops, film drops, brine drops and sea-salt particles) and rainfall-delivered salts, such as sodium chloride, and potassium, magnesium and calcium ions. Aerosol and salts are corrosive agents of steel.
Inadequate coating system – Galvanized or painted surfaces were compromised during construction or were not properly applied resulting in metal being subject to corrosion.
